**NUCAP R&D CENTER**  
**SHEAR TEST REPORT**  
 v2007.10

NU-14C-ST1826  
 05/03/2014  
 01:08:52 PM

Nucap Test Number : NU-14C-ST1826	Test Type : Ambient Test
Batch Identification : D87	Lining reference : D87-I
Sample area at point of shear : 8093 mm <sup>2</sup>	Sample size : 1
Customer Contact Name : DAVID CAMERON	Sample Type : Full Pad
Test Engineer : N/A	Name of Tester : HARMINDER
Reference Number : N/A	Comments : D87 INNER PAD/CERAMIC
Location Clean Areas : N/A	Deviation from test procedure : N/A

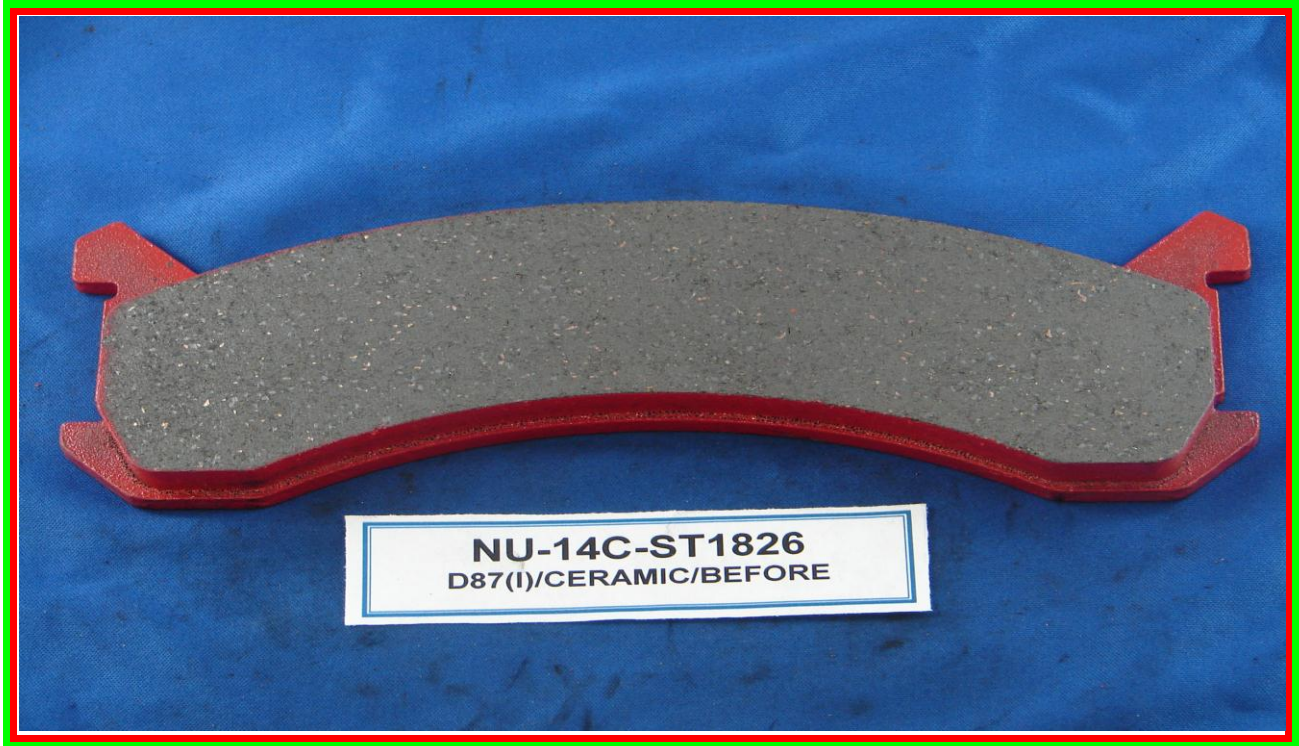
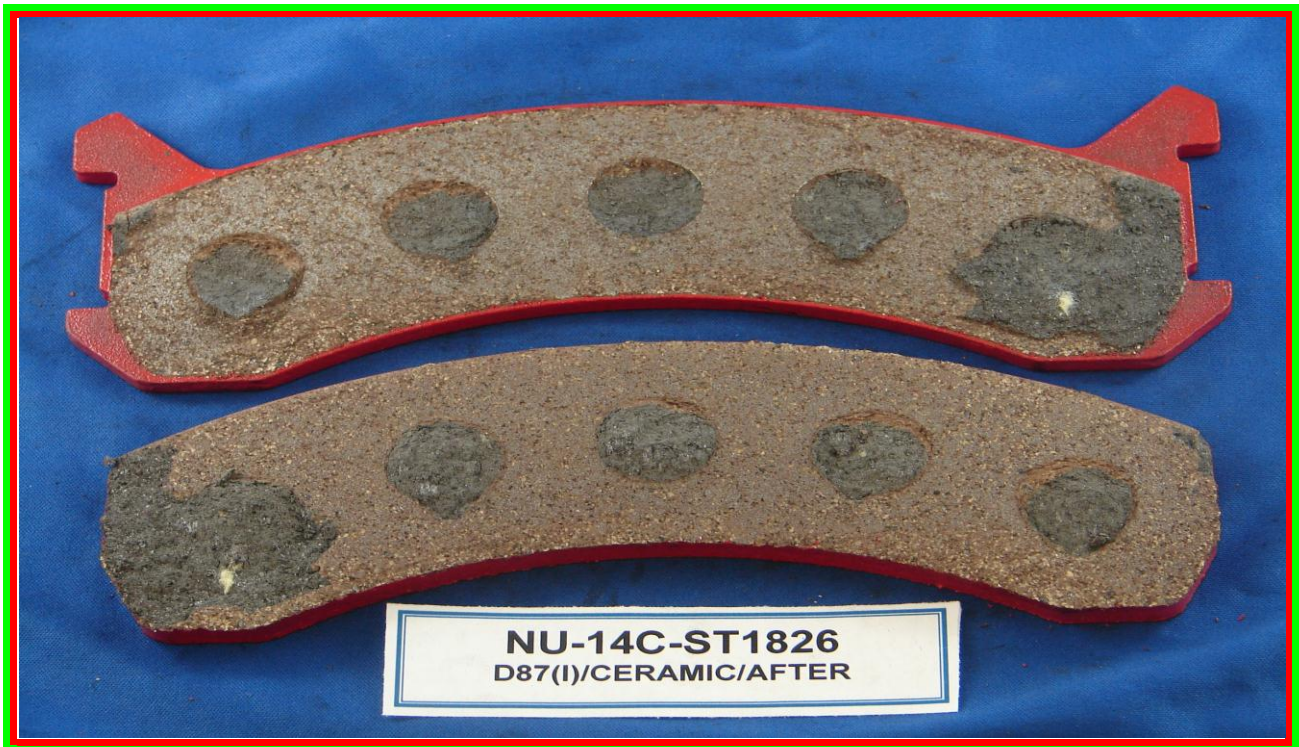
Nucap Test #: NU-14C-ST1826

Cust Ref. D87/INNER/CERAMIC

Clean carrier : 0.0%  
 Adhesive : 90.0%  
 Failure in lining : 10.0%

Sample Number	Sample ID	Shear Load (N)	Shear Strength (MPa)	Failure Type
1	INNER	36771.99	4.54	Adhesive
